Rapid Service Update (RSU)
Potential Sunroof Noise

REFERENCE:	TSB: 23-004-23 REV. A GROUP 23 - Body	Date:	January 31, 2023	REVISION:	23-004-23
VEHICLES AFFECTED:	2022 (MV) Jeep Compass This bulletin applies to vehicles built on or after **September 14, 2022 (MDH 0914XX)** and on or before October 29, 2022 (MDH 1029XX) equipped with Full Sunroof, Power Front, Fixed Rear (Sales Code GWJ).			MARKET APPLICABILITY:	
				<input type="checkbox"/> NA	<input type="checkbox"/> CH
				<input checked="" type="checkbox"/> EE	<input type="checkbox"/> IAP
				<input checked="" type="checkbox"/> SA	<input checked="" type="checkbox"/> MEA
CUSTOMER SYMPTOM:	Customers may comment on the following: <ul style="list-style-type: none"> Audible sound coming from the rear sunroof area over rough roads. 				
CAUSE:	Missing adhesive between interior roof frame panels.

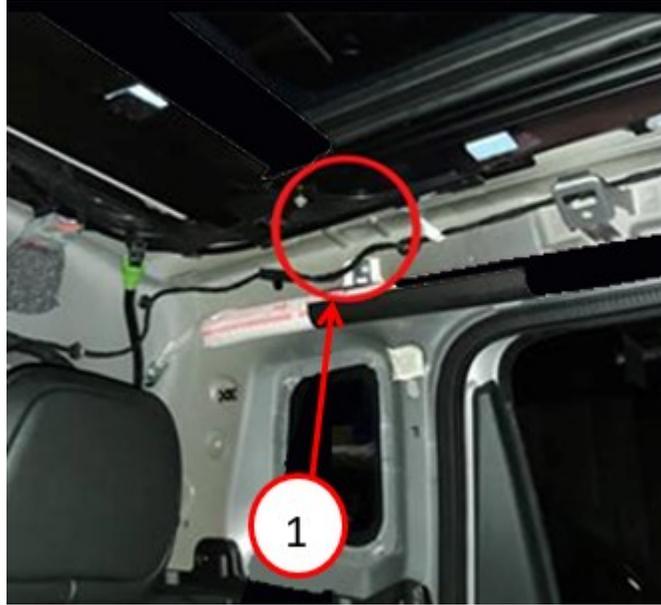
Fig. 1
Sealing Area

1. Remove the headliner. Refer to the detailed service procedures available in DealerCONNECT> Service Library under: Service Info>23 - Body / Interior / Headliner / Removal.
2. Locate the area above the C-pillar window that needs sealing ([Fig. 1](#)).

1 - Roof Panel Sealing Area

3. Seal the rear roof frame panels together (Fig. 2) . Apply a large bead of adhesive between the panels and let dry.

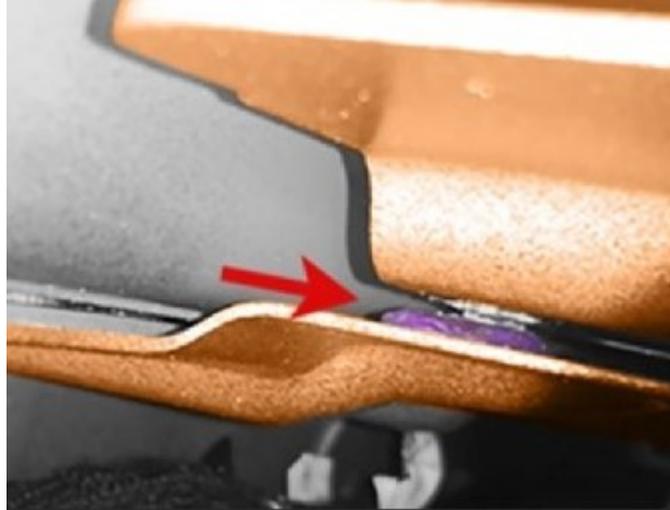
Fig. 2

Adhesive Application Location

NOTE: Follow the instructions on the adhesive for application and drying times.

NOTE: Both the right and left sides of the roof panel will need to be sealed.
