REFERENCE:	TSB: 08-112-23 GROUP 08 - Electrical	Date:	April 29, 2023	REVISION:	08-037-22 REV. A
VEHICLES AFFECTED:	**2017 - 2023 (MP) Jeep Compass** 2021 - **2023** (WL) Jeep Grand Cherokee 2022 - **2023** (WS) Grand Wagoneer/Wagoneer 2019 - **2023** (KL) Jeep Cherokee	MARKET APPLICABILITY:			
CUSTOMER SYMPTOM:	Some customers may report that on occasion, vehicle exterior tail lamp assemblies are fogged with a light layer of condensation on the inside of the lenses. This may be reported after the lamps have been turned on and brought up to operating temperature, turned off, and then rapidly cooled by cold water (such as rain, or the water from a vehicle wash).				
CAUSE:	Moisture build up in the tail lamp assembly. Lens fogging can also occur under certain atmospheric conditions after a vehicle has been parked outside overnight (i.e., a warm humid day followed by clear cool night). This will usually clear as atmospheric conditions change to allow the condensation to change back into a vapor. Turning the tail lamps on will usually accelerate this process.

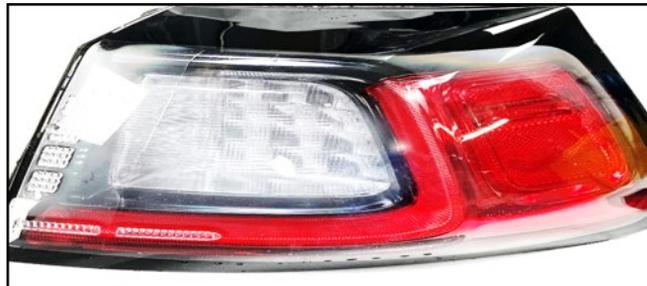
Fig. 1
Clear Tail Lamp Assembly

2. The tail lamp should be checked every 10 minutes.
 - a. If the condensation/fogging has begun to clear from the tail lamp lens within 60 minutes with the tail lamps operating, this indicates the tail lamp sealing has not been breached, and the tail lamp does not need to be replaced (Fig. 1) .

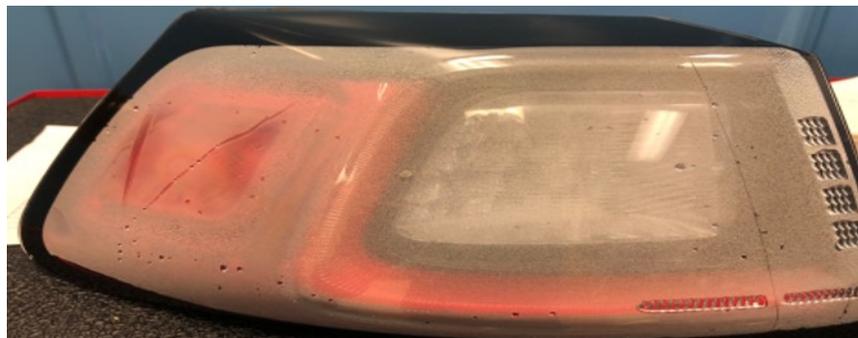
Fig. 2
Tail Lamp Assembly with Condensation

- b. If the condensation/fogging has not begun to clear after 60 minutes with the tail lamps operating, or the lamp has large amounts of water droplets visible on most internal surfaces, this indicates a problem with the tail lamp sealing that has allowed water to enter the tail lamp. In this instance, the customer is also likely to report that moisture in the tail lamp is always present and never disappears (Fig. 2) . A tail lamp that exhibits internal moisture permanently should be replaced. Refer to the detailed service procedures available in DealerCONNECT/Service Library under: Service Info> 08 - Electrical / 8L - Lamps and Lighting / Lamps/Lighting - Exterior / Lamp, Tail / Removal.

1. A tail lamp that exhibits condensation/fogging should be evaluated in a service bay environment by first drying all water from the outside surface of the lens and operating the lamp for 60 minutes by starting the vehicle and turning on the head lights and hazard lights.
